**The refurbishment and upgrade of the Kyalami Grand Prix Circuit has entered its sixth month. The final layers of asphalt are now all laid as work continues on various other elements of the project.**

## A milestone achieved - Kyalami has its new asphalt surface

## How the structural problems at Ingwe were solved.

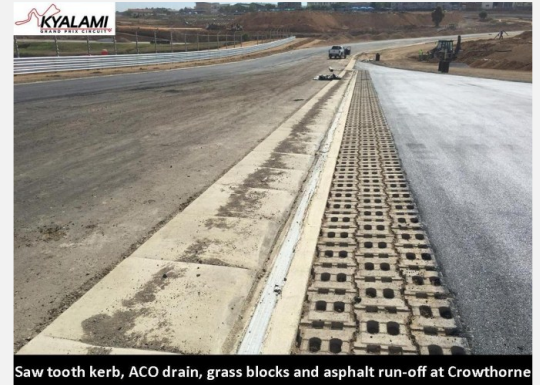
Saw tooth kerb, ACO drain, grass blocks and asphalt run-off at Crowthorne

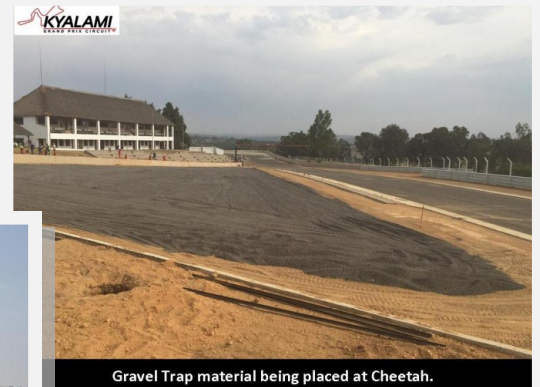
Gravel Trap material being placed at Cheetah.

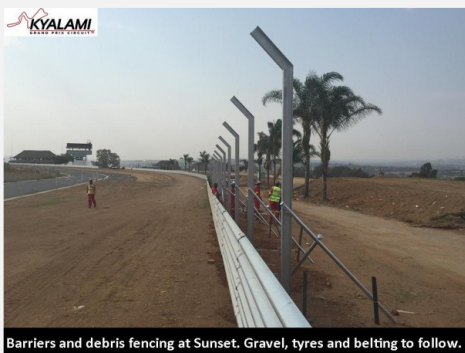
Barriers and debris fencing at Sunset. Gravel, tyres and belting to follow.

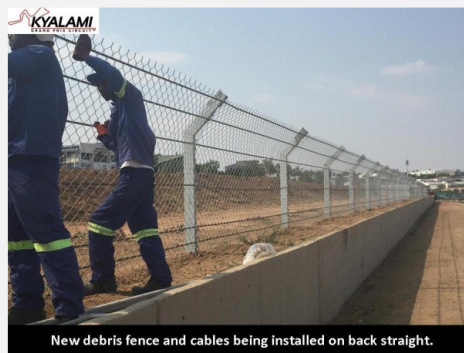
New debris fence and cables being installed on back straight.

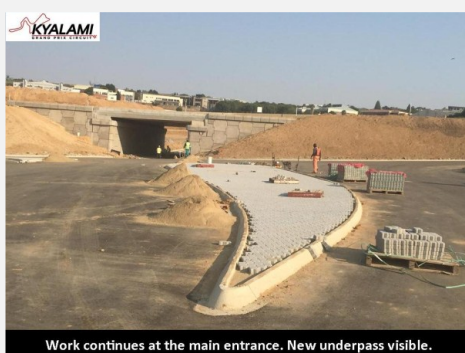
Work continues at the main entrance. New underpass visible.

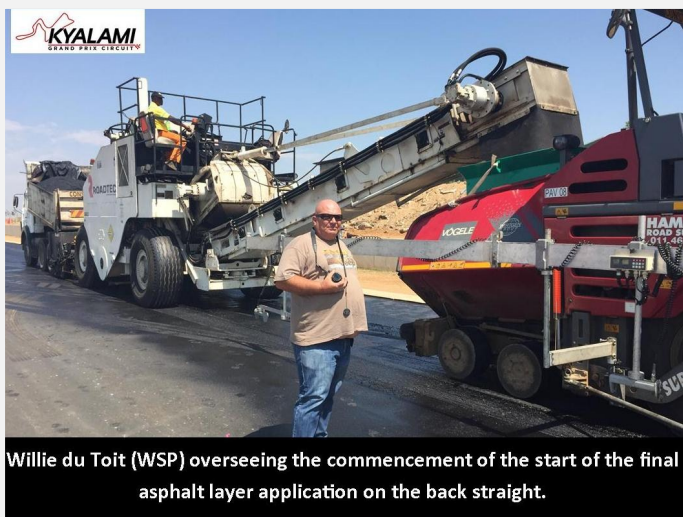
Willie du Toit (WSP) overseeing the commencement of the start of the final asphalt layer application on the back straight.

The first layers of asphalt were placed on the track in mid September. During the 30 day period of the project over 10 000 tons of asphalt was placed by the team led by Willie du Toit from WSP. Work on the new asphalt run-off area at Ingwe corner and the surrounding service roads are also now completed.

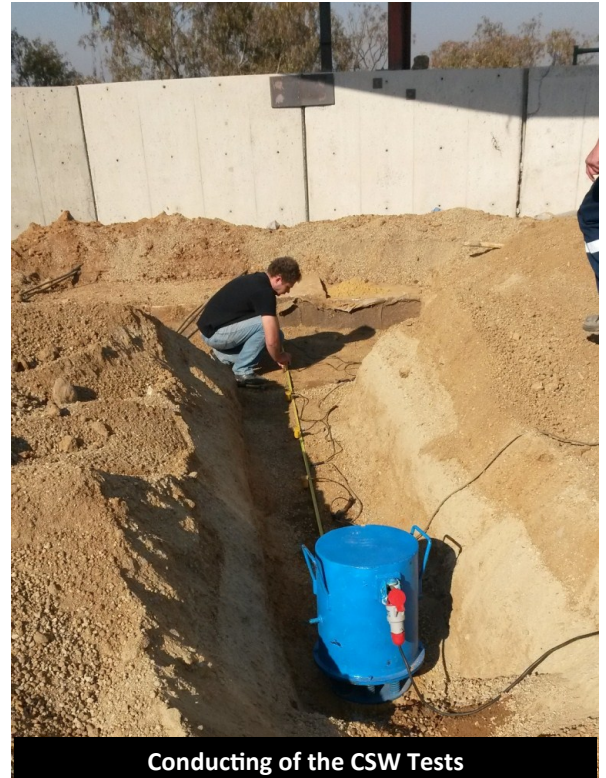
It was initially postulated that the cause of the movement was due to weaker zones within the fill material. In order to confirm this, continuous surface wave (CSW) tests were conducted. These are non-invasive in situ tests that measure the stiffness of the underlying soil layers by inducing vibrations in the soil and measuring the resulting shear wave velocities passing through the various layers. It is possible to reach depths of up to 20m, if required. The CSW tests confirmed the presence of soft spots, although these were generally limited to the upper layers.

Conducting of the CSW Tests

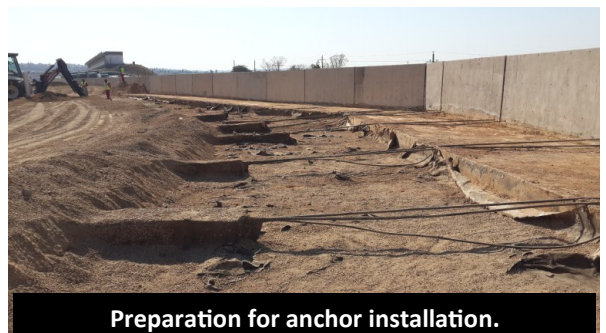
Preparation for anchor installation.

Install R32S self-drilling anchors (SDA) as micro-piles with a 90mm f ES drill bit spaced 2.0m apart to a depth of some 15m. An SDA system comprises a hollow threaded steel bar with an attached sacrificial drill bit that performs both drilling and grouting in a single operation,

These were installed along the critical perimeter of the retaining wall, offset so that they did not intersect the soil nails already in place, also installed at 2.0m c/c. A total of 53 no. micro-piles were required,

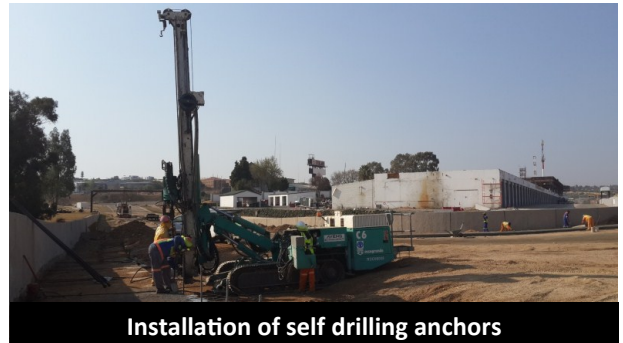
Installation of self drilling anchors

SDAs are suitable for difficult ground conditions, but more importantly are relatively fast to install since drilling, placing and grouting are performed in a single operation. This was a major advantage for this project where time was considered critical and a fast but reliable solution was required.

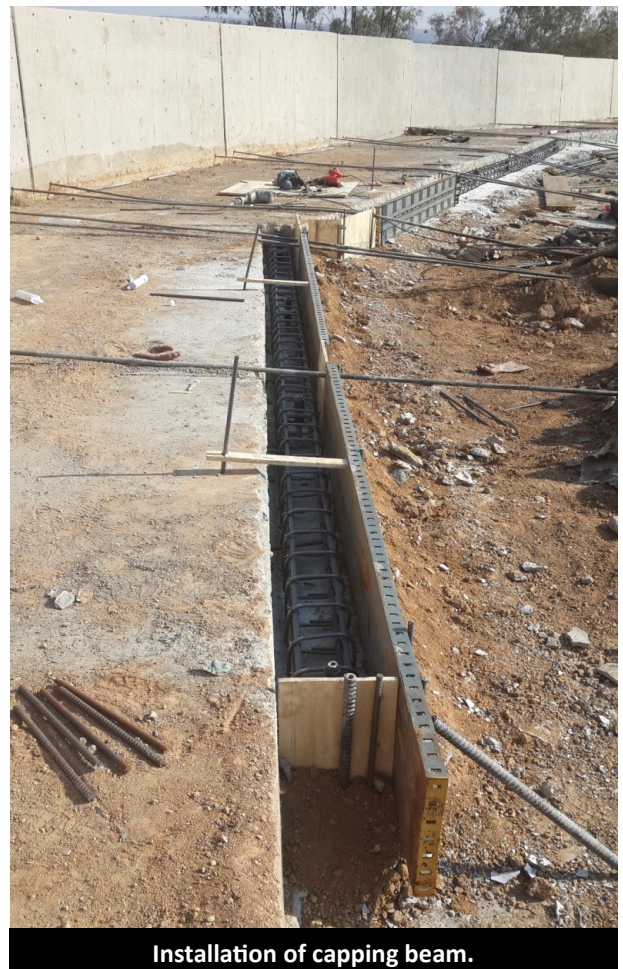
Installation of capping beam.

The pile top was connected with a 300 x 300mm capping beam installed such that the top was approximately 300mm below road/arrester level. This capping beam is typically reinforced with 100kg of steel per cubic metre of concrete, and was tied into the foundation of the existing side wall via dowel bars.

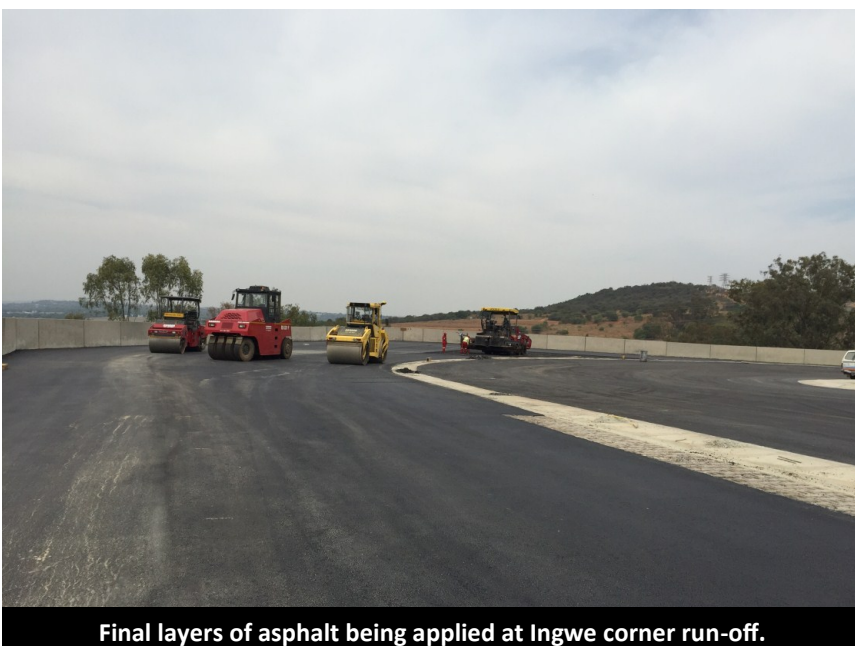
Final layers of asphalt being applied at Ingwe corner run-off.
